Retaining walls damaged in the Chi-Chi earthquake

Y.S. Fang, Y.C. Yang, and T.J. Chen

Abstract: This paper investigates the failure of three gravity walls due to the 1999 Chi-Chi earthquake. Characteristics of the damaged walls were carefully recorded and backfill materials behind the damaged walls were collected and tested in the laboratory. Both the simplified analysis based on the Mononobe–Okabe method and the simplified dynamic analysis based on the Richards–Elms method were adopted. For the first case, the sliding of concrete wall blocks along the construction joint was observed. It was found that, during the earthquake, the frictional resistance at the untreated construction joint was not sufficient to resist the dynamic lateral thrust. For the second case, the retaining wall settled significantly and tilted about its toe. Seismic analysis of the wall indicated that, under the same horizontal acceleration, the factor of safety against bearing capacity failure was lower than that against overturning and sliding. A stability check against bearing capacity failure for the retaining wall should never be neglected. For the third case, the retaining wall built on top of the Che-L

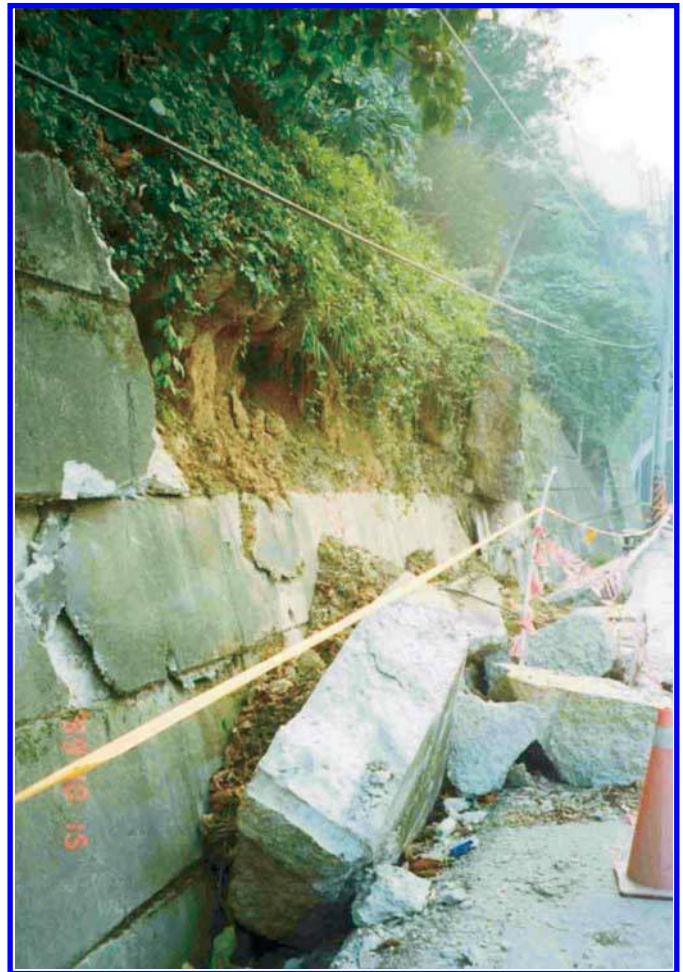
**Fig. 4.** Outward movement of the gravity wall along construction joint.

The cross section of the collapsed wall at site 1 is shown in Fig. 3. It is clear in Figs. 3 and 4 that sliding failure occurred along the construction joint A–B. Therefore, stability analysis was carried out only for the upper two blocks of the wall. It is true that, due to the earthquake excitation, sliding failure could occur along any of the construction joints. To limit the scope of this study, however, the FSs were only determined for blocks 4 and 5 of the wall which actually failed. The coefficient of friction at joint A–B was assumed to be 0.5. It is obvious that the actual value of the friction coefficient depends on the roughness of the upper and lower surfaces in contact.

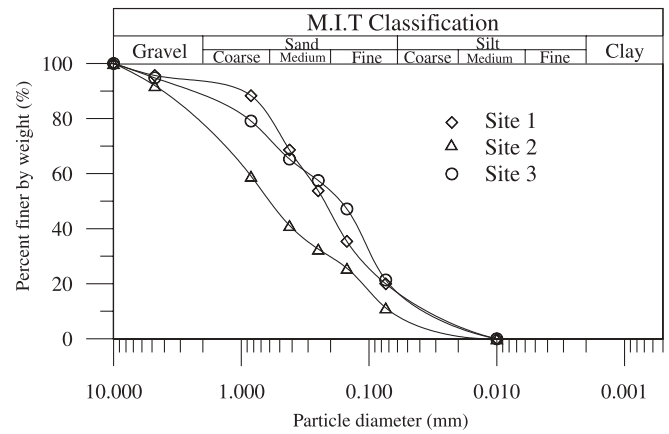
gradation curves of the soil samples are illustrated in Fig. 5. In the field, the contractors are generally required to compact the soil to at least 90% of standard maximum dry density. To simulate the performance of the backfill in the field, the soil sample at its optimum moisture content was compacted in the laboratory with the standard Proctor method and then tested with the direct shear apparatus. Seed and Chan (1959) reported that samples compacted dry-of-optimum tend to be more rigid and stronger than samples compacted wet-of-optimum. From a practical point of view, in this study the soils collected from the sites were compacted at the optimum moisture content and then sheared to failure. The strength parameters obtained are listed in Table 2 and were used in the stability analyses of the retaining walls.

Fig. 5. Grain-size distribution of backfill materials at sites 1–3.

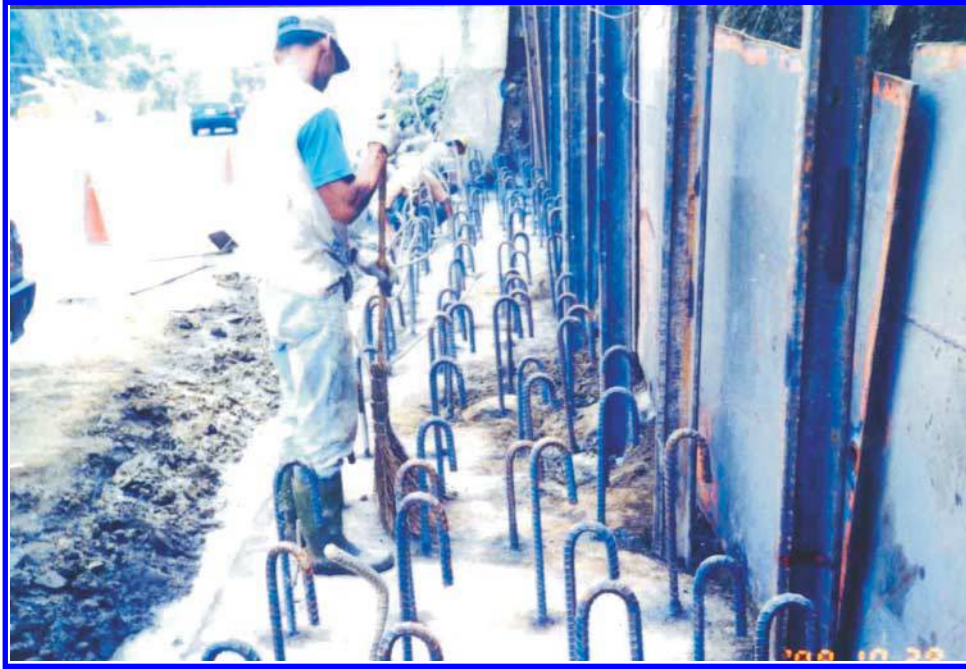
Fig. 8. Shearing reinforcement at construction joint.

potential movement of the steep slope. The installation of a shearing key would be another efficient method to prevent sliding failure at the construction joint.

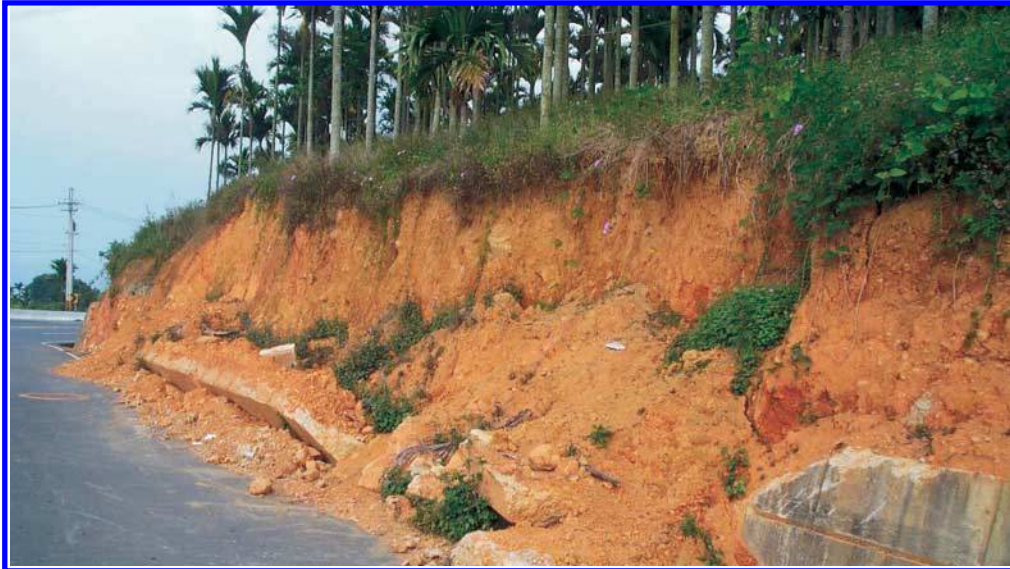
The damaged retaining wall was built near Sun-Moon Lake and is labeled as site 2 in Fig. 1. The gravity wall was built to retain the steep slope for the construction of Provincial Highway 21. After the Chi-Chi earthquake, the retaining wall settled significantly and tilted about its toe as shown in Fig. 9. Little lateral movement of the wall was observed. The active soil wedge behind the wall collapsed, however a large portion of the wall body remained undamaged. The beetle-nut plantation on the uphill slope remained stable during the earthquake.

Fig. 9. Overturning of gravity wall at site 2.

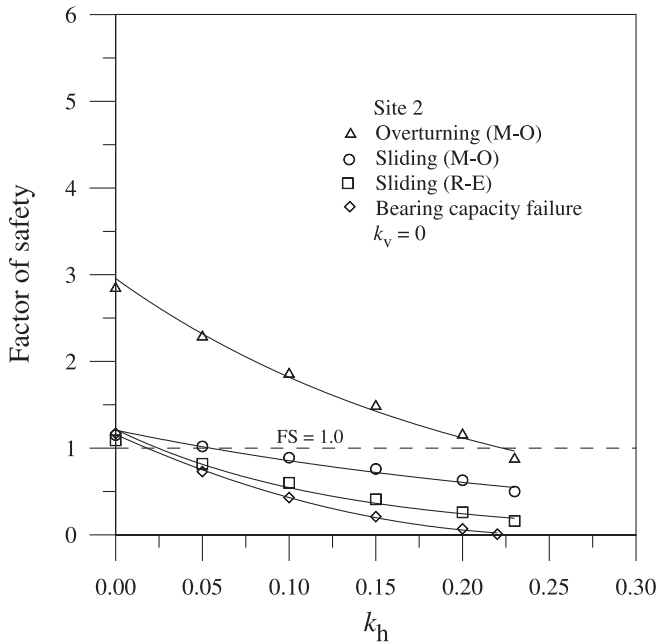
The variation of FS for the gravity wall at site 2 as a function of the horizontal seismic coefficient k_h is shown in Fig. 11. It was assumed that the foundation soils had been compacted and had the same properties as the backfill. The resisting force against sliding at the base of the wall can be expressed as

Under a static condition, the FS against sliding is only 1.15. This value is unacceptable for design, since it is less than the required FS of 1.5. In Fig. 11, the FS against sliding decreases with an increase in the horizontal acceleration. With the Mononobe–Okabe method, the FS against sliding would be less than 1.0 for a horizontal acceleration greater than $0.05g$. With the Richards–Elms method, the wall would start to slide as the horizontal acceleration exceeds $0.025g$. It is clear in Fig. 10 that the wall is relatively short and thick

and should exhibit good resistance against overturning. In Fig. 11, at any k_h value, the FS against overturning is apparently higher than that against sliding. This analysis indicates that the wall should slide instead of overturn under seismic shaking. This finding is contrary to the wall behavior observed in the field.

Fig. 11. Factor of safety of wall at site 2 as a function of seismic coefficient.

The variation of FS against bearing capacity failure is also indicated in Fig. 11. Under the same seismic coefficient, the FSs obtained are slightly lower than the FS against sliding. During the Chi-Chi earthquake, the horizontal PGA recorded at the nearby station TCU-079 was $0.59g$. Under such a strong seismic vibration, the overturning wall movement was most probably triggered by insufficient bearing capacity under the toe. Based on this case study, it could be concluded that a stability check against bearing capacity failure for the gravity wall should never be neglected.

It should be noted in Fig. 11 that, even under static loading, the FSs against sliding and bearing failure are very low. Figure 13 shows how the variation of soil friction angle affects the analytical results prior to the earthquake. Based on the laboratory tests, the angle ϕ of the compacted backfill is assumed to be 31.0° . In Fig. 13, if ϕ is reduced to 29° , bearing failure would be more likely. However, the FS against bearing failure increases rapidly with an increase in ϕ . If ϕ is increased to 33° , the FS against bearing failure would be 2.18, and sliding becomes the possible mode of failure.

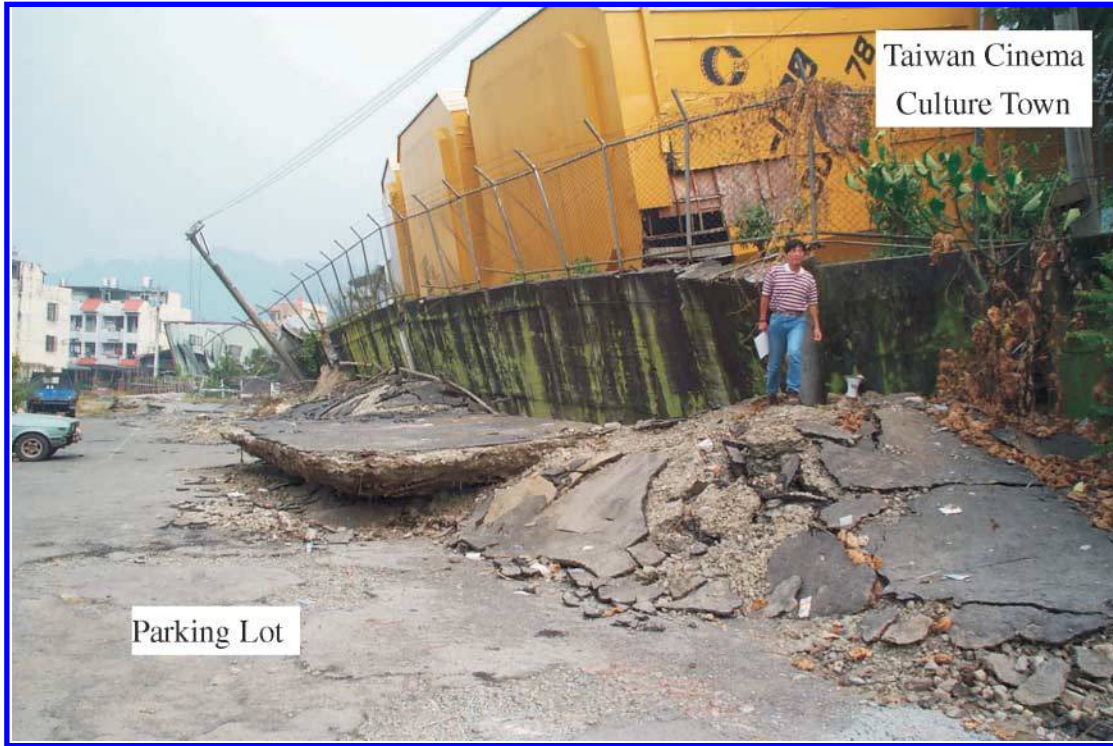
Figure 14 shows the failure of a gravity wall located at the Taiwan Cinema Culture Town (site 3) near the township of Wu-Fung. The wall was constructed right above the Che-Lung-Pu fault. During the earthquake, the fault rupture caused the wall to slide and overturn. Figure 14 shows that the power pole tilted along with the retaining wall. The body of the wall remained unbroken, however. Ground heave in front of the toe is quite obvious in Fig. 14. The backfill behind the wall cracked, and the buildings constructed on the backfill were severely damaged by the ground deformation and strong ground shaking.

Fig. 14. Sliding and overturning of retaining wall at site 3.

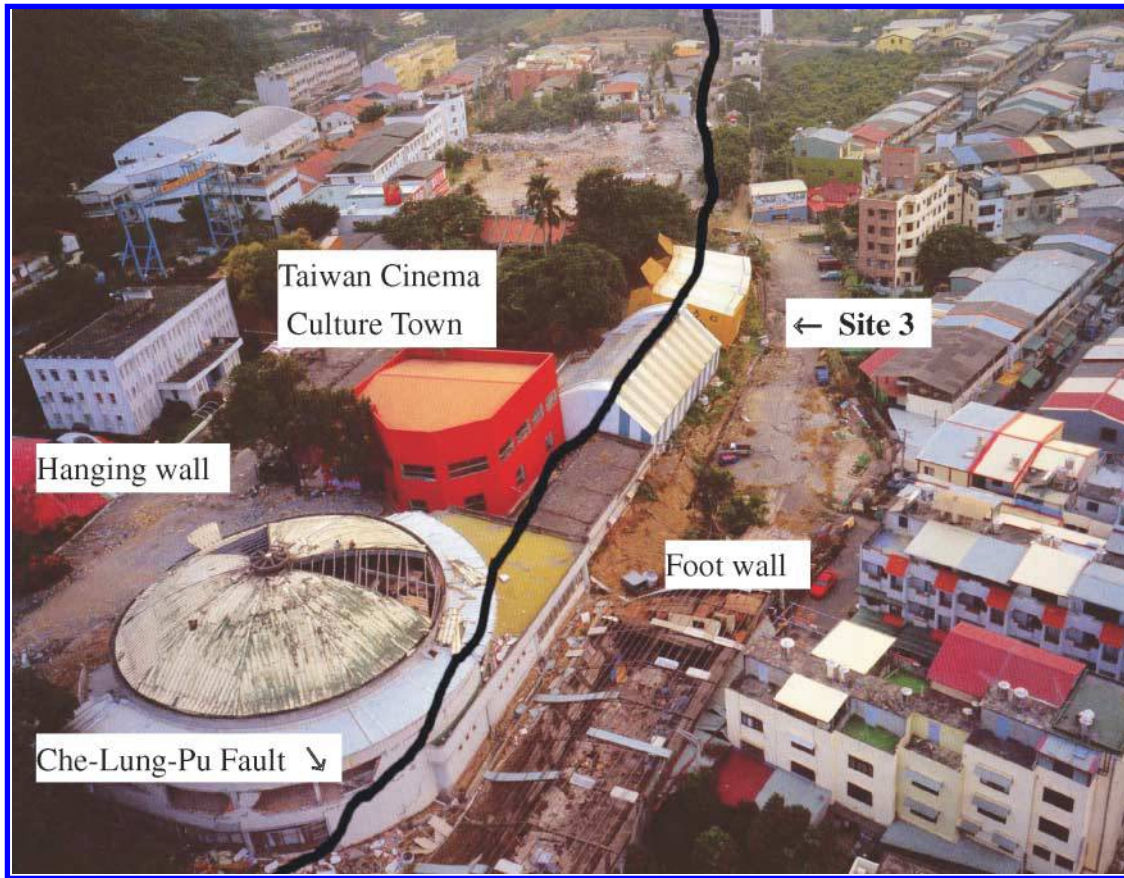
Fig. 16. Che-Lung-Pu fault cut through Taiwan Cinema Culture Town (after Sino-Geotechnics Research and Development Foundation 1999).
